Beach Erosion Update

6-24-24

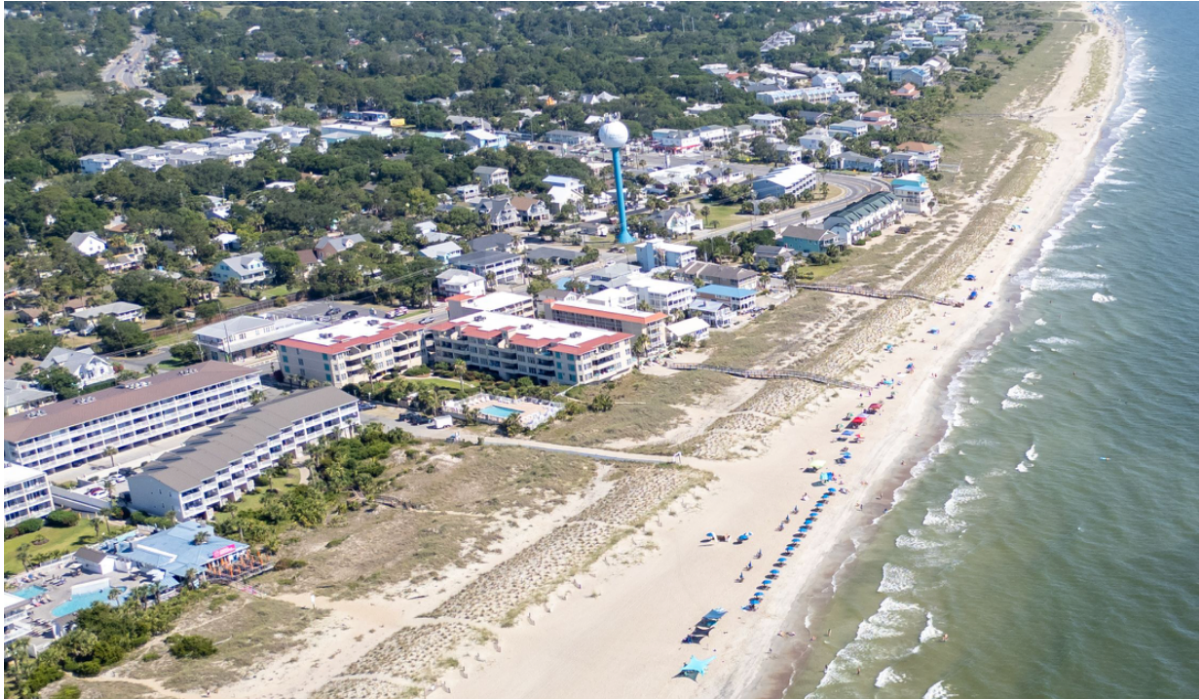
Picture taken June 8, 2024, courtesy AWR Strategic Consulting

The beach is showing severe erosion at the traditional points of the island following the recent period of sustained strong northeasterly winds.

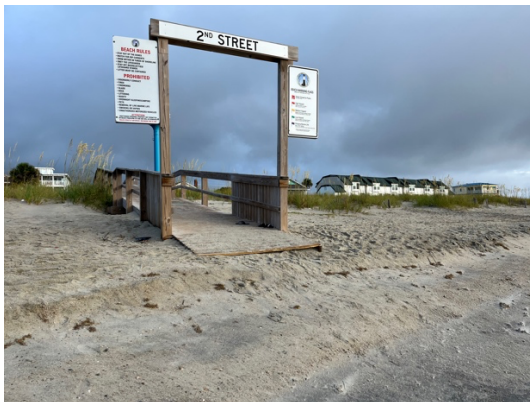
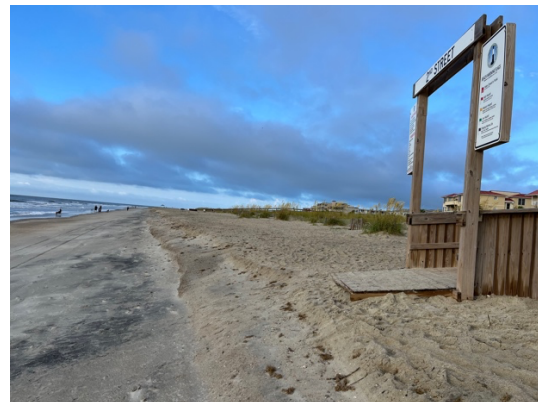
Picture taken June 23, 2024, courtesy AWR Strategic Consulting

In particular, the crosswalk at 2nd Street, among others is at risk during high tide:

The City began working with the Savannah District US Army Corps of Engineers Savannah District earlier this year to design and plan the next full nourishment, expected in two years, December 2026. The Corps' planning cycle is such that this is the earliest the beach nourishment can be done. While certain access points (i.e. 2nd Street) will lose beach, the full length of the beach Federal template (South Groin to North Groin) is still well within the Corps' parameters and will not justify an earlier nourishment.

Given two more summer seasons (2025 and 2026) before the beach is nourished, we can expect to see some crosswalks shortened or even closed at high tide over the next two years. While this will be an inconvenience at times, we want people to be aware and informed to consider these factors when visiting the beach.

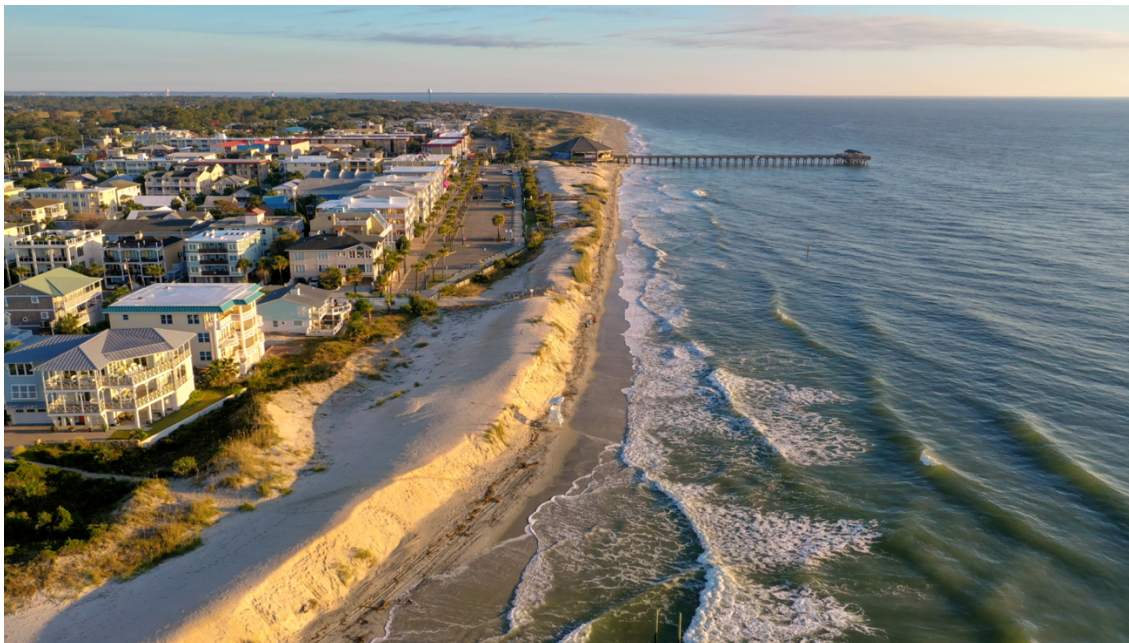
Picture courtesy of AWR Strategic Consulting

As a reminder, during the 2019 season (picture below) prior to the last nourishment, there was no beach between Tybrisa Street and 18th Street at high tide:
